CPC FLOOR COATINGS

CASE STUDY:

Saluda Hydroelectric Transformer
Containment Project

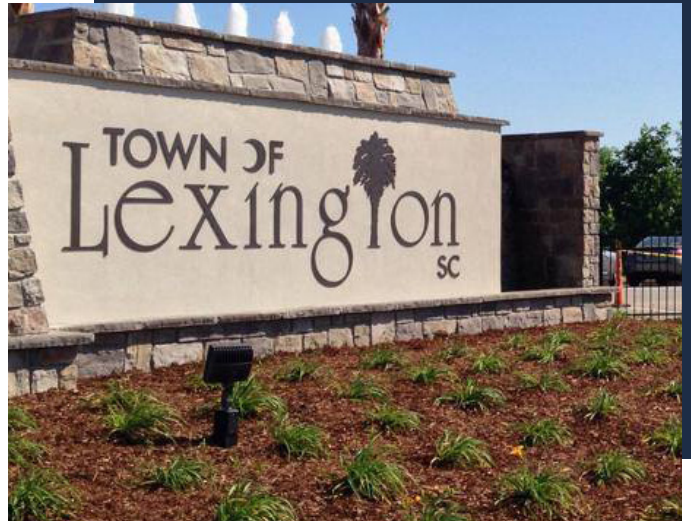
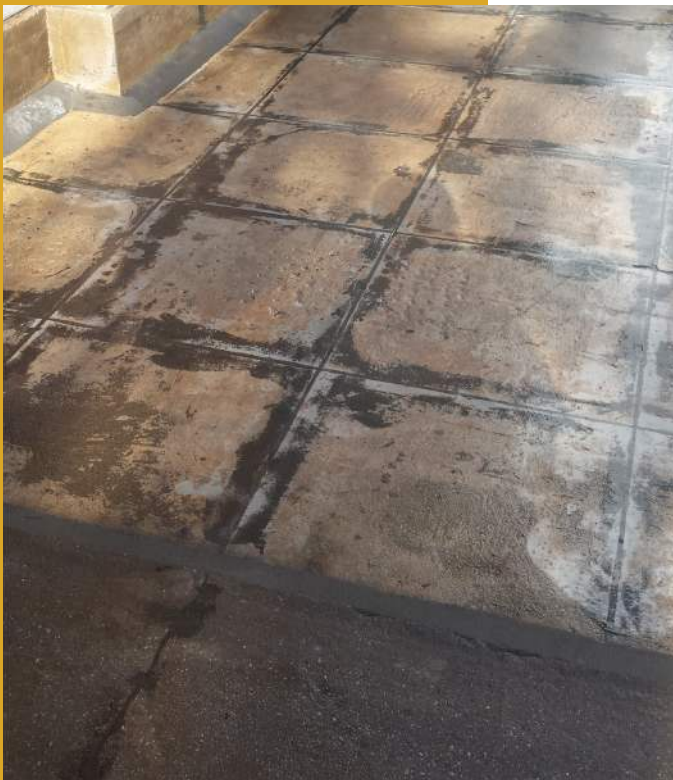
The containment areas for the plant's transformers are located on a 1,930-square-foot elevated concrete slab, which had begun to leak rainwater into the rooms below.

The concrete cant cove had also been damaged over time, and there were other sections in which new cove needed to be added. Several pipe penetrations also needed to be sealed off.

First we started by prepping the surface, using a wet-abrasive blast cleaning process to achieve a particular profile (in this case, CSP 3). Surface preparation is the most important step to ensure coating system adhesion.

After surface preparation, our team had to repair damage to the concrete slab itself. We used the Tnemec Series 206 flexible epoxy to fill cracks. In addition, our crews tackled more than 400 feet of cant cove, handling both repairs and new installation. The pipe penetrations were sealed off using fiberglass cloth and the same flexible epoxy.
